Re: Request for Information
San Fernando Valley Area I/North Hollywood Superfund Site
North Hollywood, California

**SUBJECT: INSPECTION REPORT: FORMER ALLIED SIGNAL (NORTH HOLLYWOOD)
PUBLIC STORAGE/HOME DEPOT FACILITY
11600 SHERMAN WAY, NORTH HOLLYWOOD, CALIFORNIA, 91605
(FILE NO. 111.0180)**

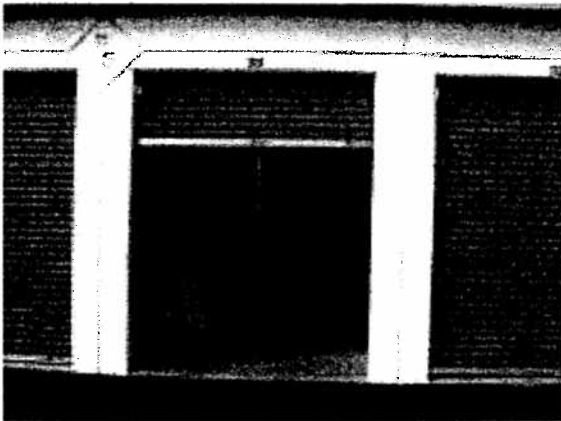
Public Storage rental space # 33, with existing well inside

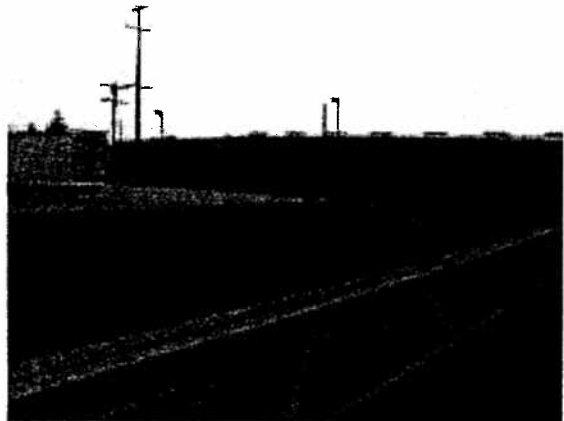
Southern boundary of Public Storage facility, former Plant 1 chemical/waste storage, maintenance and paint shops

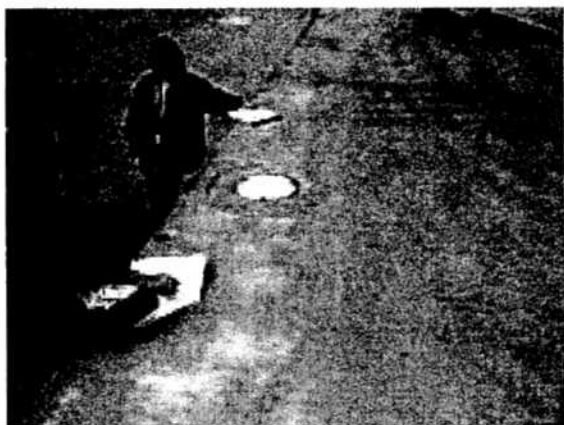
South-side of main Public Storage warehouse with existing well GW-1
